# Innavik Hydroelectric Project

## Fish and Fish Habitat

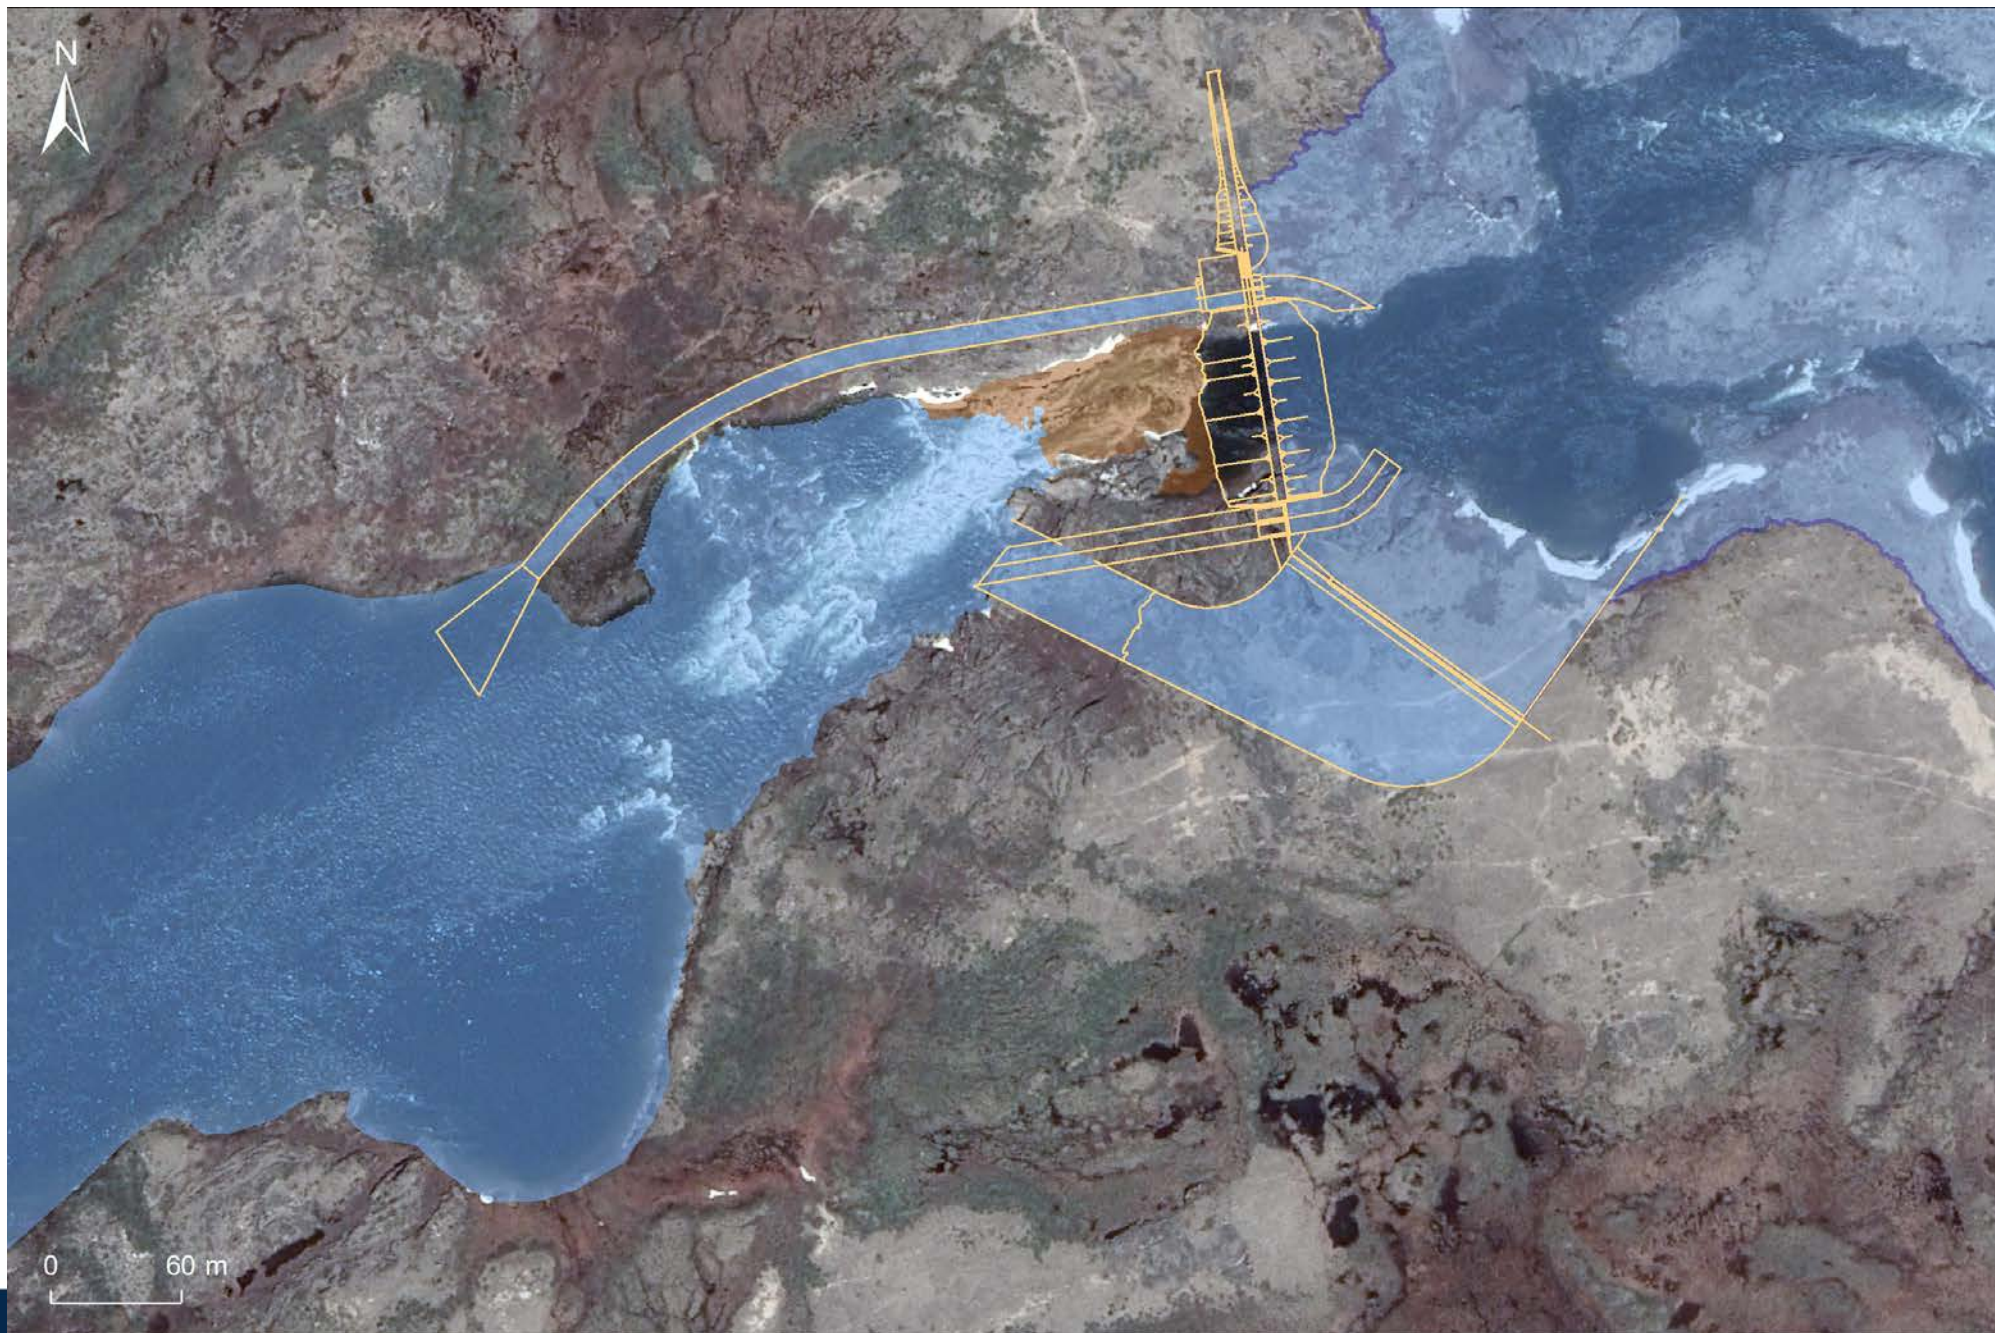
# Headpond Water Depth

Estimated Water Depth (m)
